4
NINTH/QUARTERLY PROGRESS REPORT,
FOR THE
3 APPLICATIONS TECHNOLOGY SATELLITE
GRAVITY GRADIENT
STABILIZATION SYSTEM 4

1 JULY THROUGH 31 OCTOBER

25 CONTRACT NO. NAS 5-9042 29ACV

1 GENERAL   ELECTRIC
SPACECRAFT DEPARTMENT
A Department of the Missile and Space Division 2
Valley Forge Space Technology Center
P.O. Box 8555 • Philadelphia, Penna. 19101

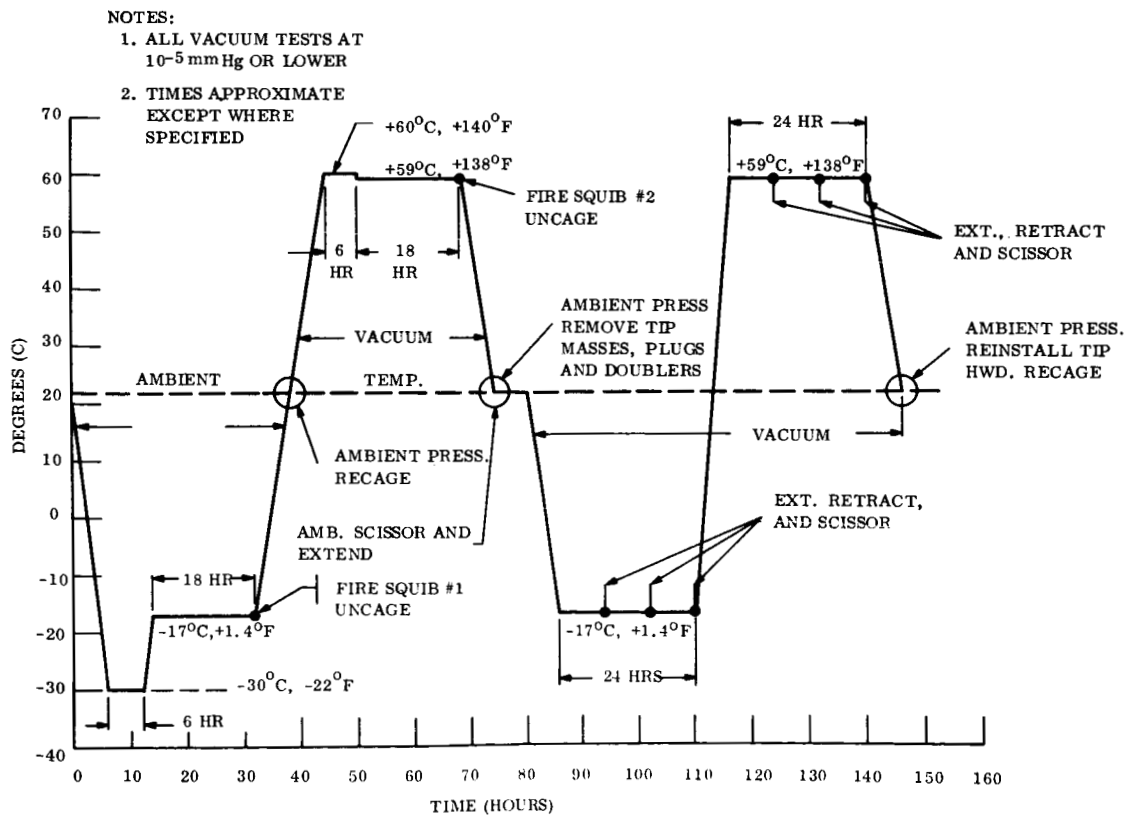
Figure 3-1. ATS Primary Boom, Qual T/V Cycle

The extension motor stalled during thermal-vacuum testing but only at the minimum scissor angle of 11 degrees; all other qualification tests were conducted successfully.

When the unit was in the thermal-vacuum environment and functioned in the operational phase (i. e., without tip masses), attempts to extend or retract the booms resulted in a stall condition of the extension motor as evidenced by high armature current (between 2.5 and 3.5 amperes). Motor stalling occurred at both extremes of temperature and vacuum, and also at ambient temperature and pressure only at the extreme negative of scissor angle; they were operated normally at any other scissor angles, including the positive scissor limit (i. e., 30°). The high armature current was a measure of the fact that a high mechanical resistance existed to motor torque. An investigation of the gear mechanism revealed that the polycarbonate housing was the cause of the resistance.

The polycarbonate housing is basically a plastic ring that is part of the erection unit suspension system on which the erection unit moves about the scissor axis. There is a slot on the circumference of the ring to allow clearance of the gear in the scissor drive train. When the scissor motion was moved to one of the extremes, slot clearance was exceeded, and the gear was stopped against the edge of the slot, thus effectively stalling the extension motor. The corrective action taken to prevent this motor stall condition was to sufficiently widen the slot in the polycarbonate ring so that the gear would not contact the ring even at minimum scissor angle.

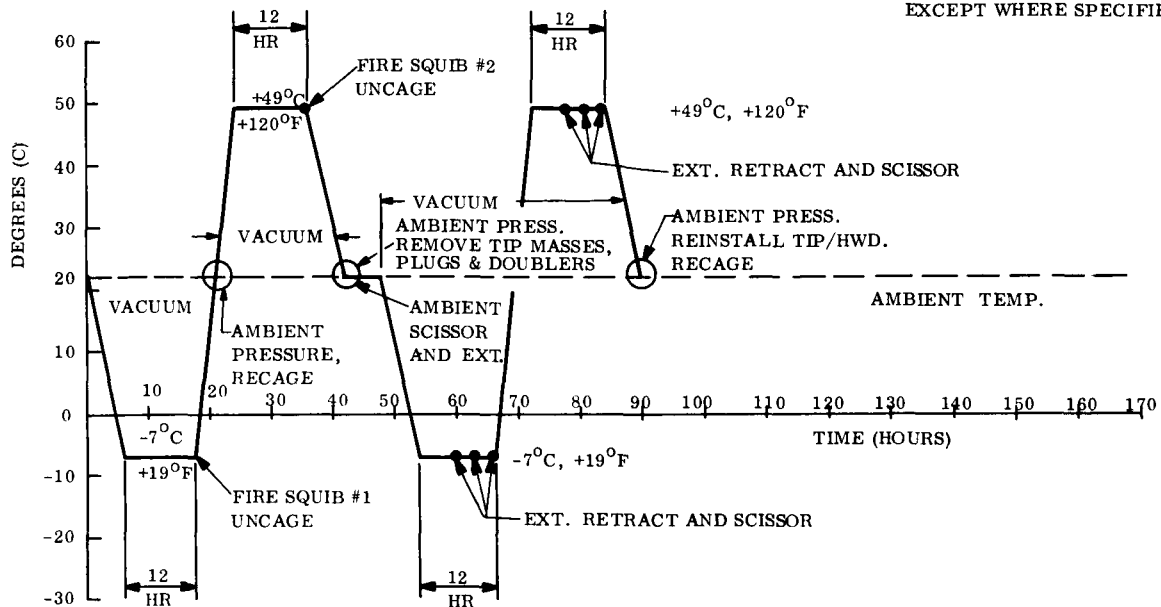
During the thermal-vacuum test (see Figure 3-2 for the temperature profile) both units encountered an uncaging difficulty at low temperature and with the tip mass deployment trolleys installed; the trolleys are part of the test equipment. Failure was attributed to the action of the test trolleys and repetition of the tests, without the trolleys, resulted in proper operation in every test. However, the details of the malfunctions are reported in GE Failure Analysis Report 255-E-26 (S/N 10 unit) and 249-E-25 (S/N 101 unit). The highlights of both failure reports are presented here for reference.

The F-1b Primary Boom (S/N 10) failed to uncage during thermal-vacuum test at cold temperature (-7°C) on 20 September 1966. This followed a similar failure of the F-1a Primary Boom (Reference Failure Analysis Report 249-E-25). Flight pyro release mechanism and live squibs had been installed and the vibration test performed. For thermal-vacuum, the test trolleys were aligned to the unit and attached to the tip masses. After Squib 1 was fired, a 200 millisecond pulse at 26 volts produced only a slight movement of the tip plugs. Three additional pulses from the uncaging panel and several using the deploy panel produced no further movement of the tip plugs or tip masses.

Figure 3-2. ATS Primary Boom, Acceptance T/V Cycle

There was no malfunction of the pyro release mechanism and it operated properly. Although the S/N 101 unit uncaged at room temperature with the test trolleys attached, analysis of the S/N 10 and S/N 101 failures indicates that both are associated with the use of test trolleys at cold temperature. That this is the actual cause is confirmed by the successful uncaging of both units at cold temperature with the trolleys removed. Incomplete uncaging with partial movement of the tip plug, and the observed backwinding, were probably caused by trolley misalignment and binding.

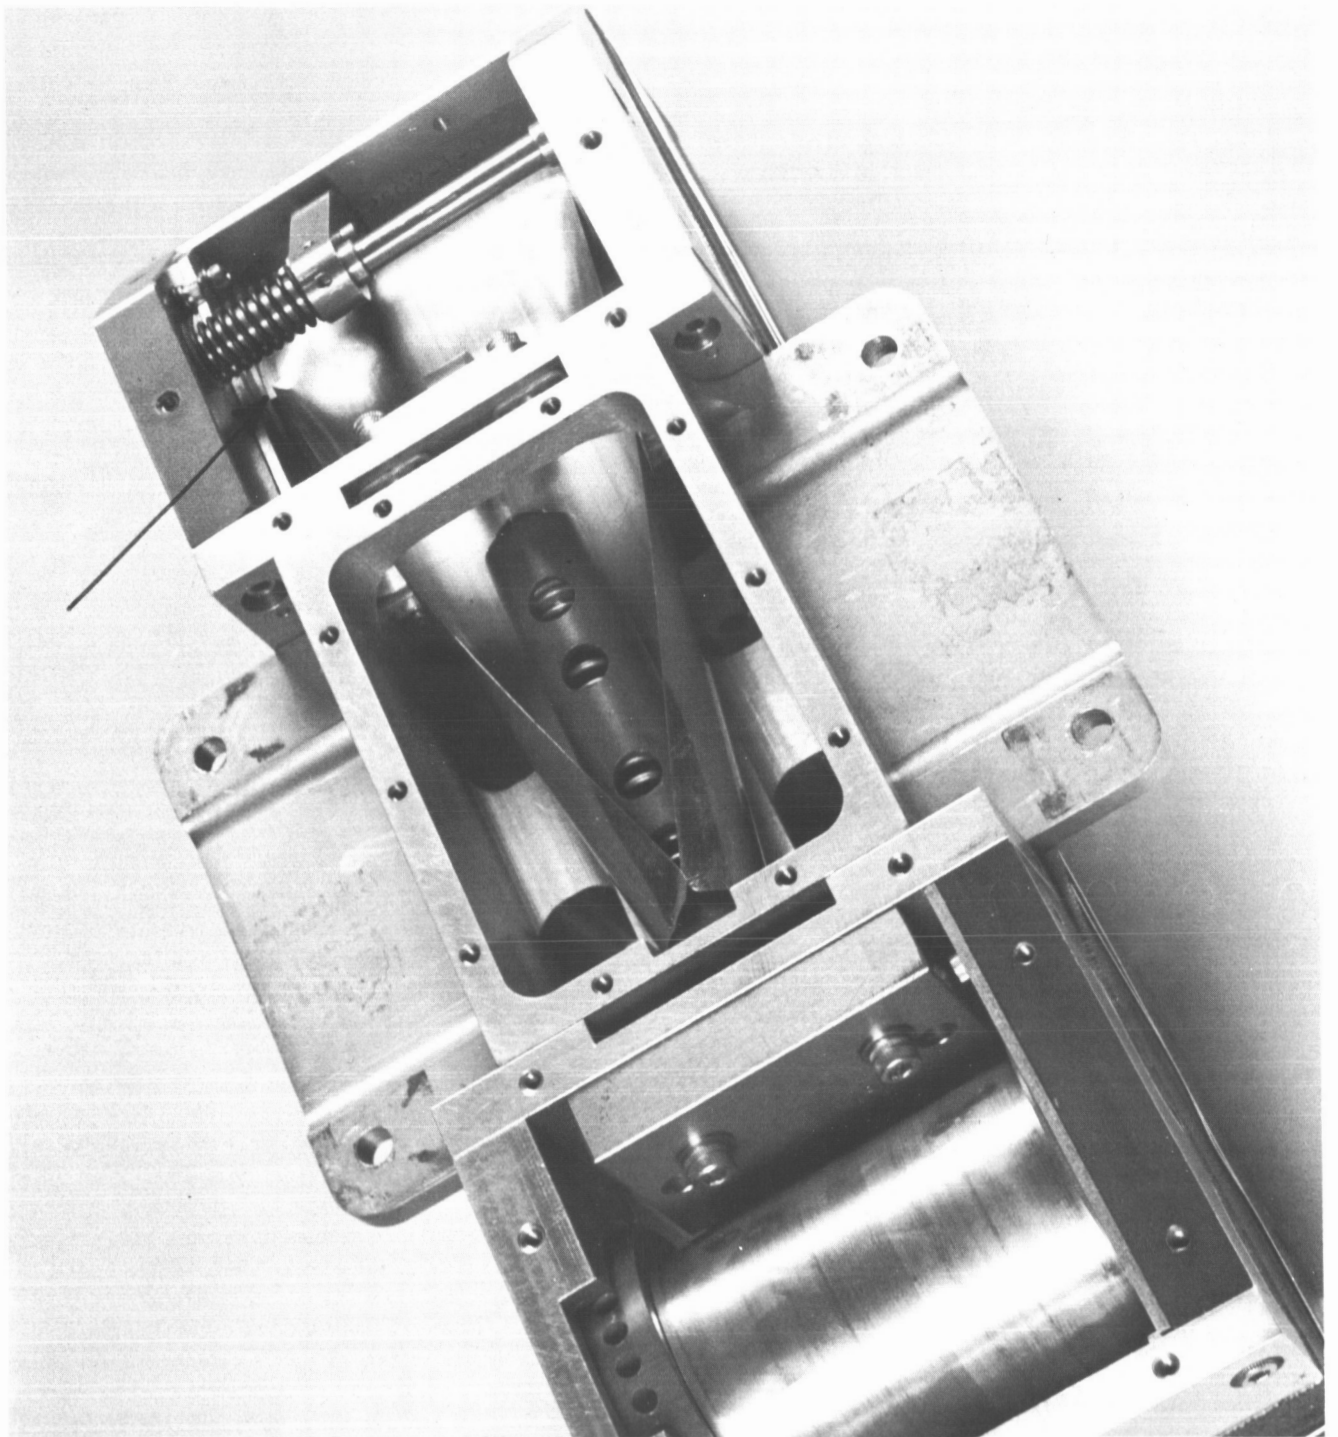
The Damper Boom was returned to deHavilland on 22 June 1966 for deployment and examination. Deployment was normal and within specification. When the covers were removed it was found that one tape had sustained a tear approximately 5/32-inch long at one edge. This tear was located at the point where the tape is tangent to the storage drum in stored condition. DeHavilland issued Operation Difficulty Report No. 18, dated 14 July 1966. The tear was in the Boom B element tape (No. 2 erection unit) but was designated tape A in this report, apparently in error. The torn tape attached nearest to the damper mounting flange of the center section.

Figure 3-3. Tear in Boom Element B Following First Vibration

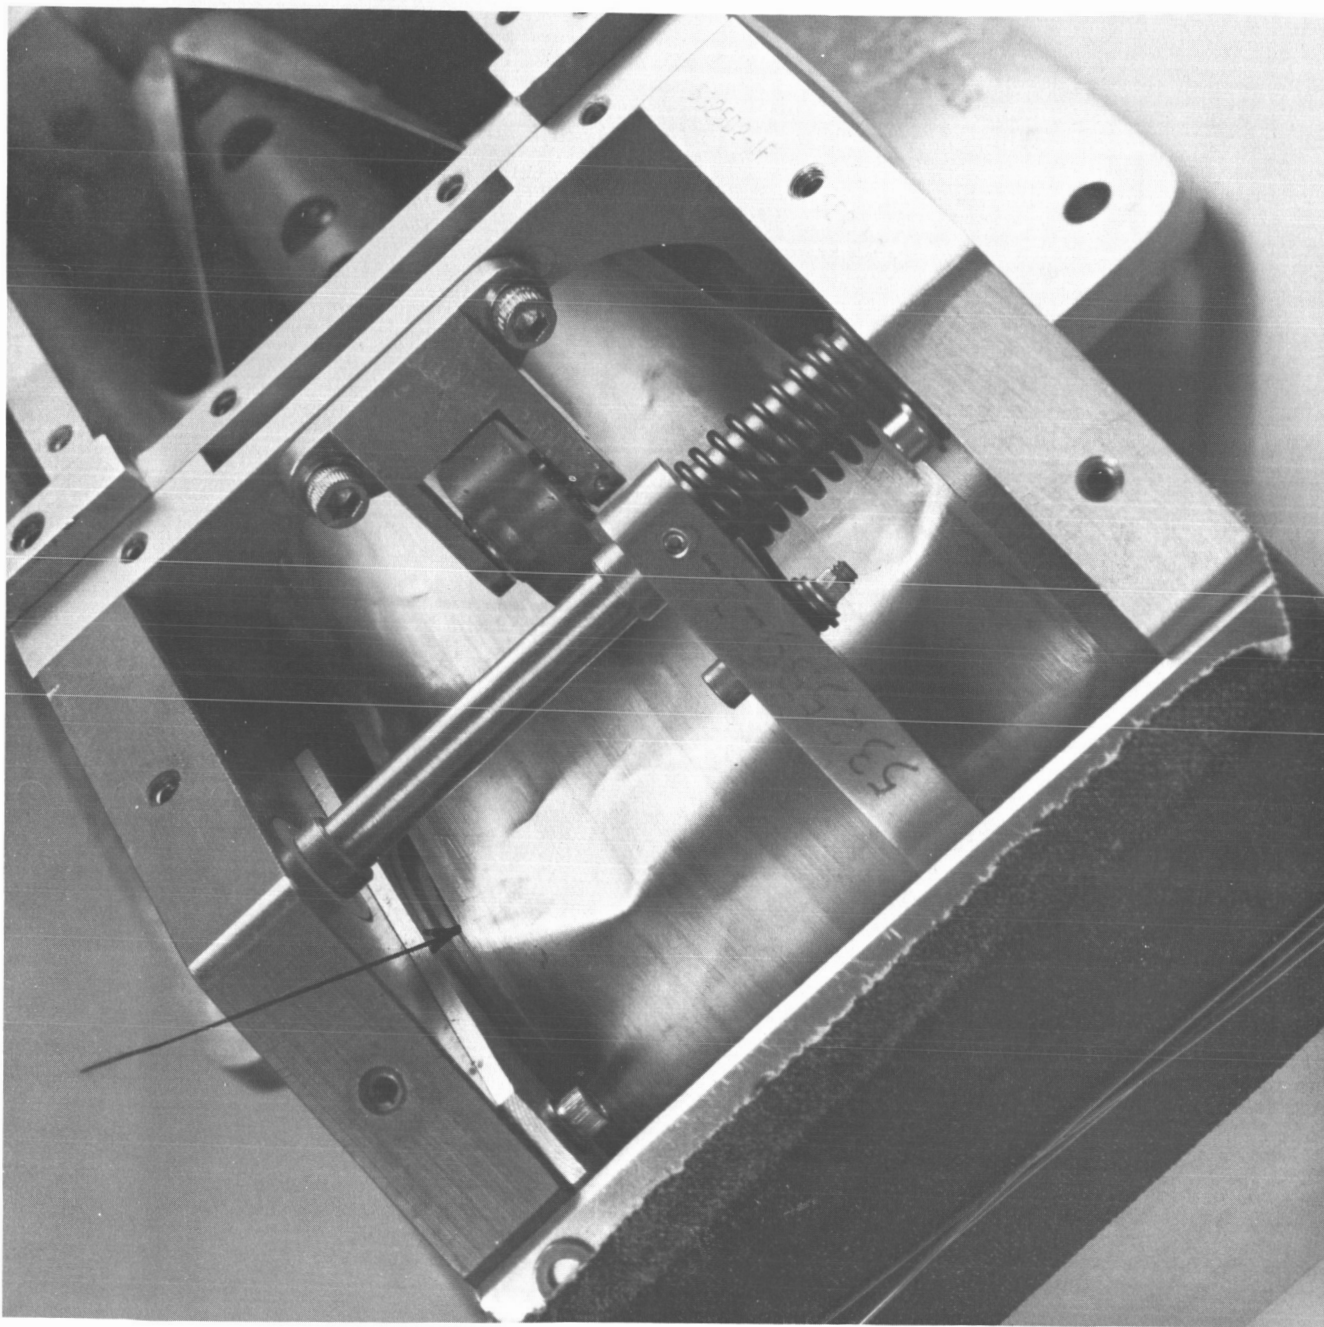
The Damper Boom Assembly was again vibrated to qualification levels on 27 July while mounted on the dynamic model CPD. It was oriented correctly with the boom axis in the plane of the Z (launch) axis. On completion of the test, the A tape was found to be cracked near the storage drum tangent point. (The opposite tape cracked on the earlier vibration test.) Both tapes were distorted and billowed on the storage drum. IR 15668 was written,

Figure 3-4. Wrinkling in Boom Element A (Untorqued)

and was dispositioned to remove the doubler tapes and to replace the old tapes with new elements. The tapes were replaced at GE by deHavilland representatives. The tapes were rewound and retorqued to a revised procedure intended to prevent billowing under vibration.

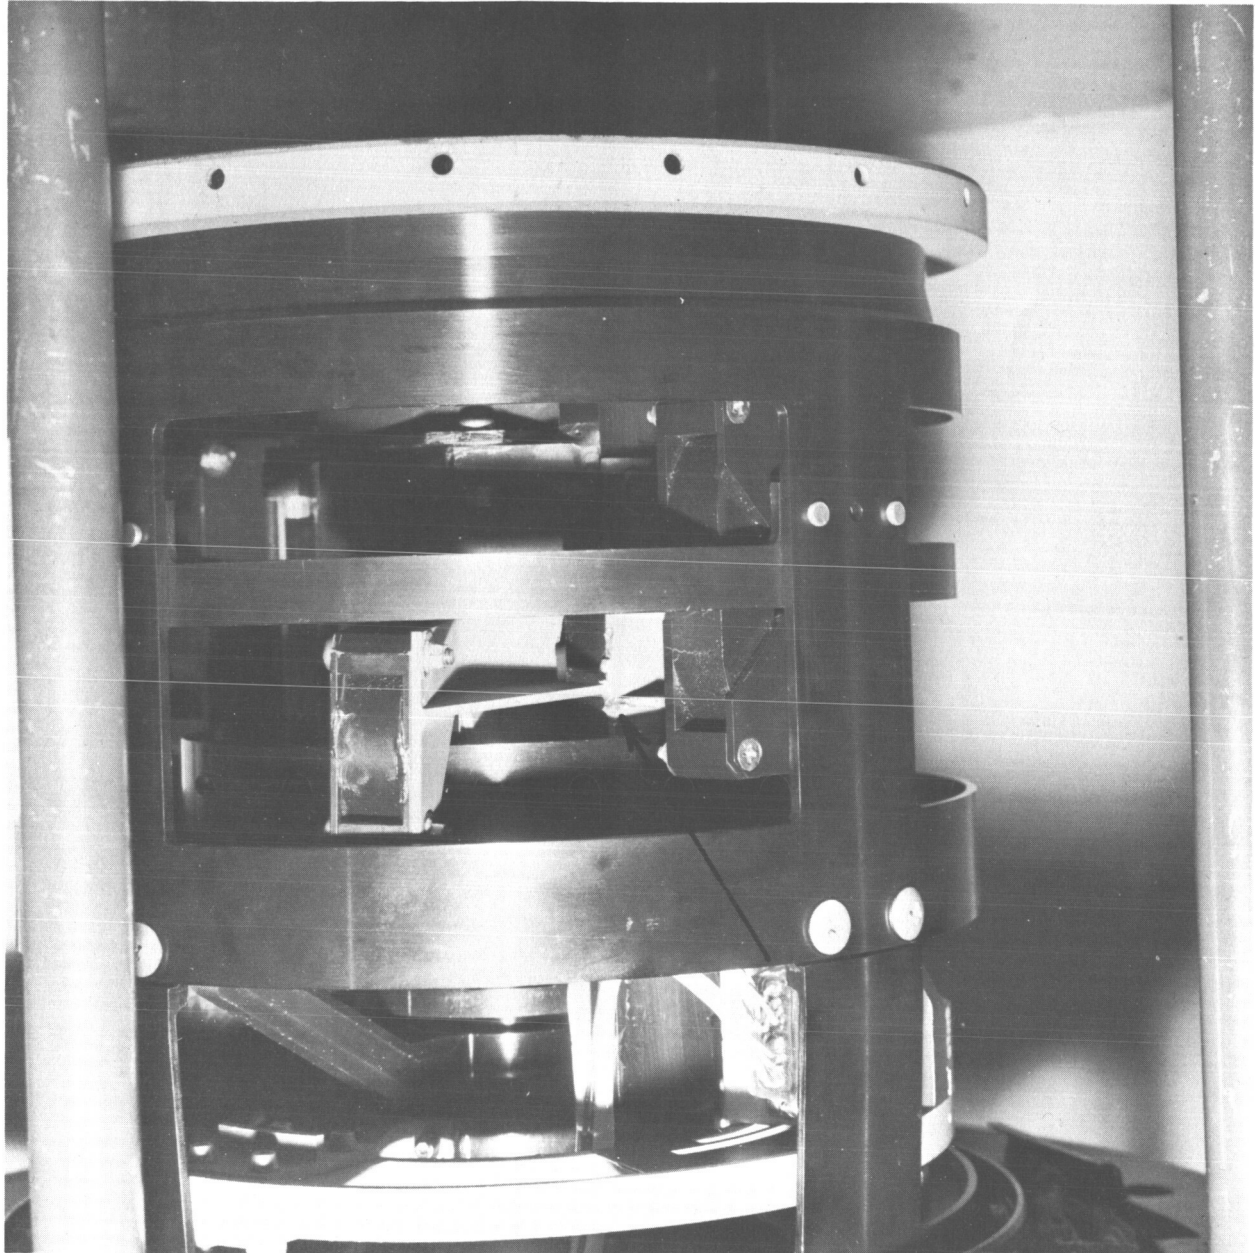
A major problem was discovered during CPD Qualification testing. The eddy-current torsional restraint magnet mounting brackets failed during the second qualification-level vibration test. Detailed analyses of the failure resulted in a design change which was incorporated into the flight equipment. Discussions of prototype qualification and flight unit acceptance testing are included in Section 4.

Figure 4-1. Failed Torsional Restraint Magnet Bracket-Quadrant II
